Troubleshooting Via M&C

Tech Support
+1 (408)782-5911
24 Hour Support Hotline
+1(669)258-9740
TechSupport@TerrasatInc.com

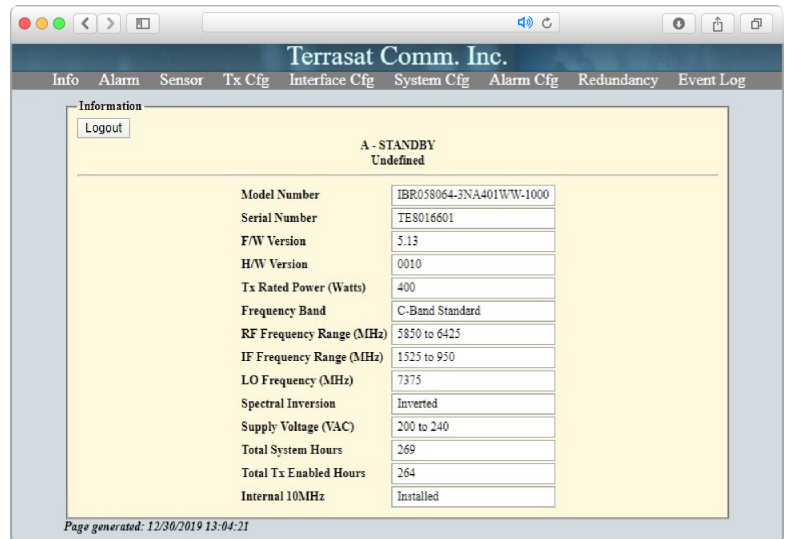
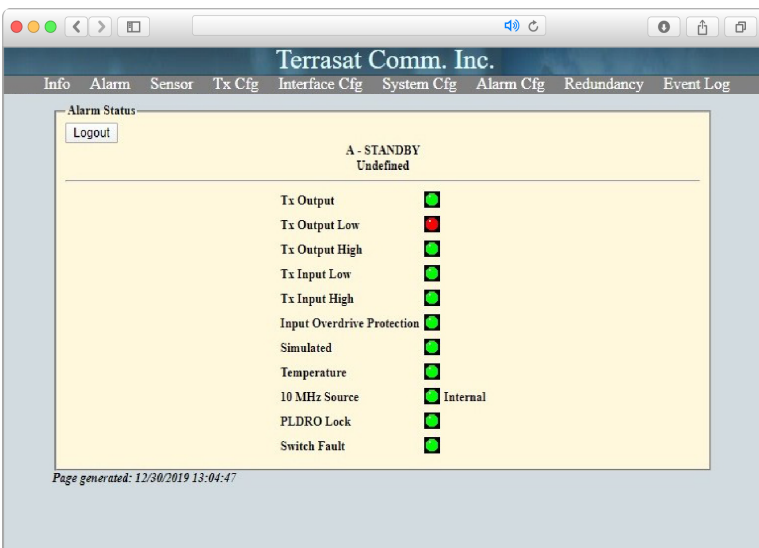
Info Tab

The Info tab provides basic information on each IBUC. It may be important to note what version of firmware the unit is on. New firmware is released regularly. The latest firmware can be found at www.terrasatinc.com/product-manuals. It is important to follow the firmware installation instructions exactly. For an up-to-date firmware changelog, please email techsupport@terrasatinc.com.

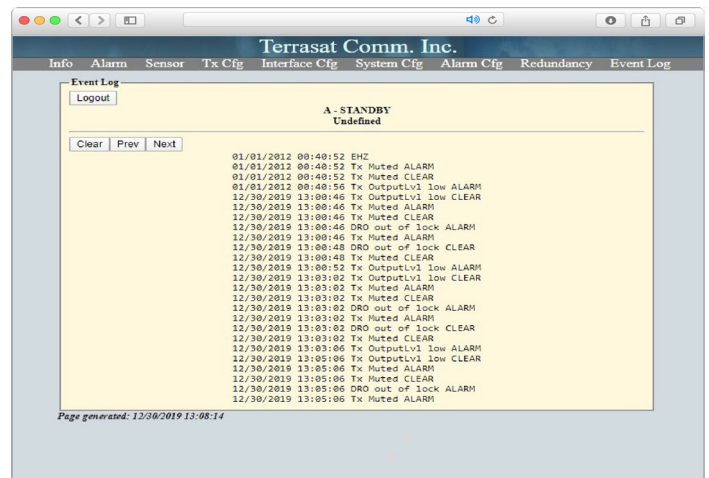
Alarm Log Tab

The Alarm Log is where alarms and events are documented. Entries are self-explanatory.

The entry "EHZ" means the alarm log was cleared.
